THE CATHEDRAL OF ALL SAINTS †

A Strategic Plan for Restoration and Improvement of Buildings and Grounds

April 19, 2021

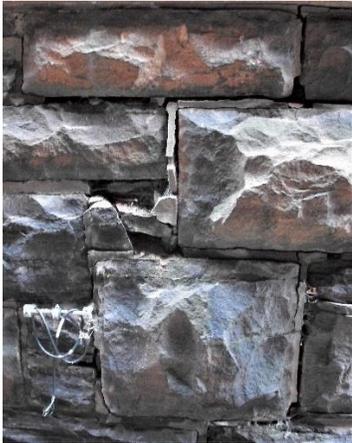
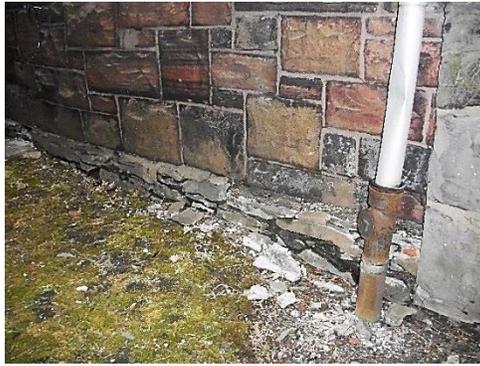
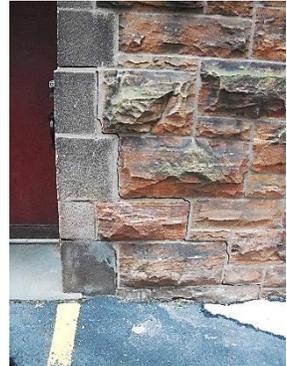
- Portland mortar joints should be repointed, but this work should start with the area where significant deterioration is present and move to areas that are subject to extreme exposure to wind and water runoff. Assume 1/4 of outside wall surface.
- All of the exterior masonry should be cleaned to remove pollutants, salt crusts, and other elements that may lead to further stone deterioration.
- The wall below the water table at the east side of the ambulatory should be rebuilt in a common brick to match the brick elsewhere on the building. Salvageable stones should be saved for repairs elsewhere on the building.
- Areas of spalled and damaged brick should be addressed so that the adjacent interior surfaces do not deteriorate. These areas include but are not limited to the southwest corner of the nave triforium, and the northeast corner of the north transept.

East Ambulatory east wall below left and middle. Bishop's entrance below right.

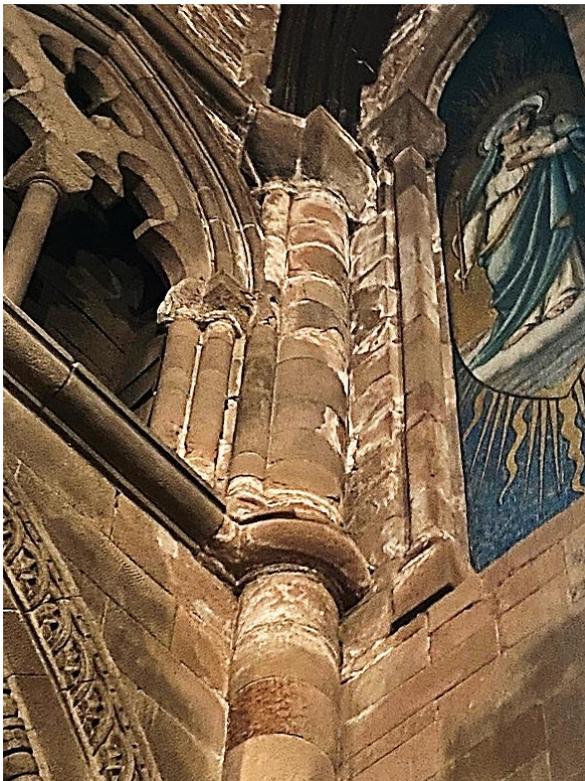
In 2020, deteriorated stone began falling, thus threatening injury to occupants. In the East Ambulatory restore four crumbling carved capitals and pilasters, seal walls to prevent exfoliation of surface stone. Restore crumbling elements in the two corners of the Chancel (northeast corner below left, southeast corner not shown), and restore stone molding and rustICATIONS in the Lady Chapel. 2020 budget prepared by Matia Restoration and Design. NOTE: This project should begin after completion of project 11.

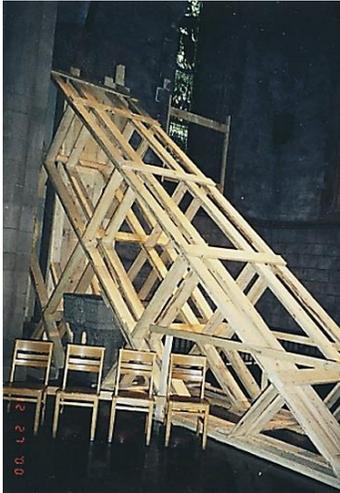
The existing conditions of all engaged buttresses should be evaluated for leakage and a plan developed to remediate unsatisfactory conditions. This includes providing a lift for access, a mason to perform discrete and isolated probes and patch, architectural field inspection, use of an inspection scope to survey interior conditions, use of thermal imaging camera to detect the presence of moisture, and a written report. Based upon LTRW experience with the Cathedral's engaged buttress repair of 2019, they anticipate each buttress to cost approximately \$1,400. 32 buttresses should be surveyed. Note: The above budget has been escalated through mid-2025. The image at left shows what had to be done the last time an engaged buttress failed (at the Baptismal Font).

A budget for remediation cannot be determined until the inspection is complete.

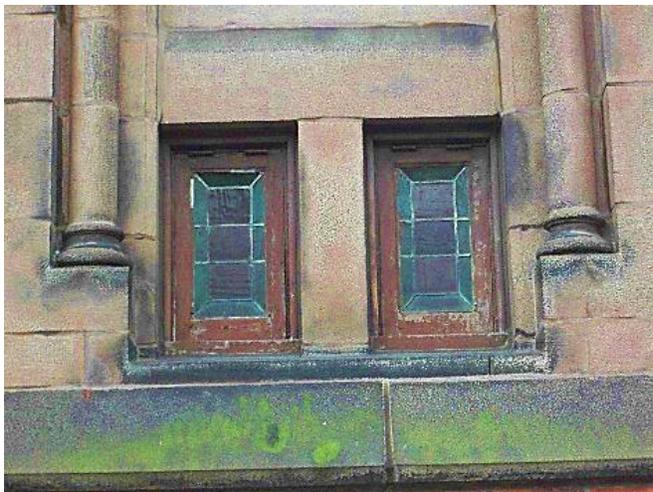
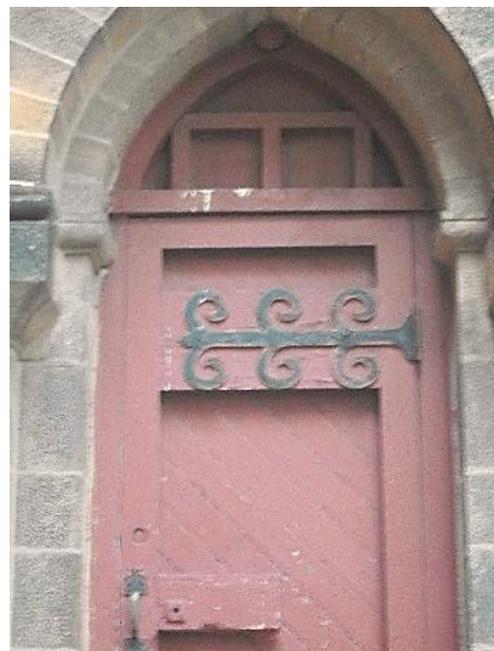
- Replace, rebuild, restore exterior doors and windows that are not decorative stained glass in the lower building perimeter to assure air and water tightness, and improve appearance.
- The wood sash and frames of sixty (60) basement level and second-story windows should be repaired and painted. Provide protective glazing at fixed windows.
- Exterior wood doors, frames, and hardware should be restored (stripped, primed, and painted in a historically appropriate manner): Baptistry, North Transept double door, Crypt, and Bishop's Entry.
- Re-build the door to St Alban's undercroft and two single doors at North Transept.
- Replace doors at northwest and southwest entrances to be consistent with other exterior doors. See all door photographs in Appendix C.

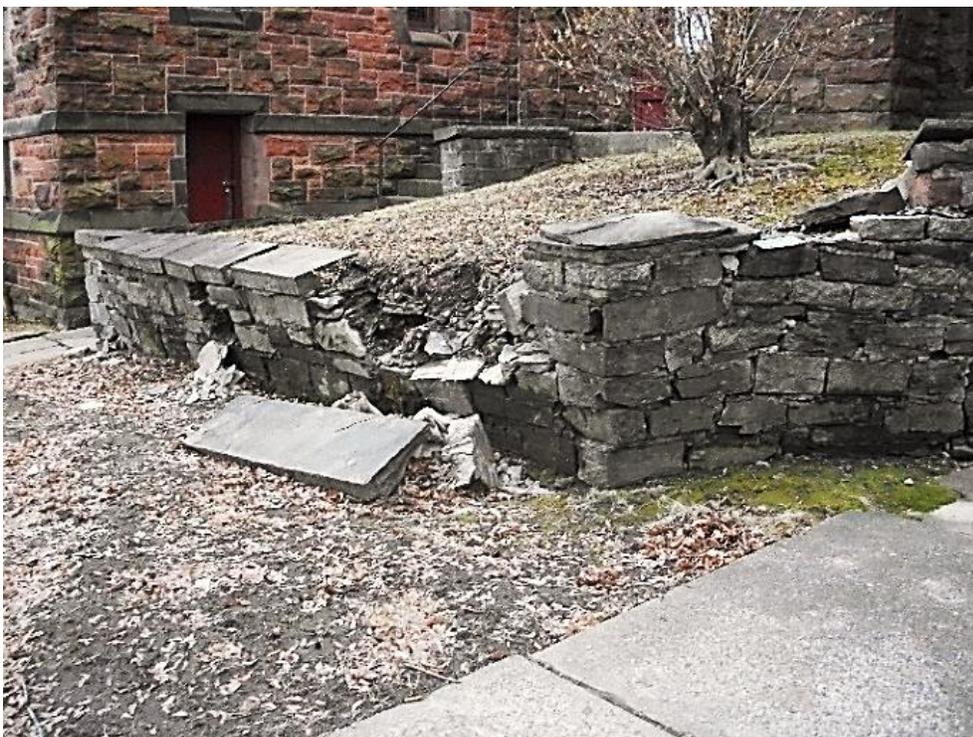
In January 2020, a part of this stone wall collapsed and instability in other parts worsened. Remove this wall, both relatively intact and fallen portions, and grade slope down to sidewalk as proposed by Tom Jenkins Excavating, LLC in 2020.

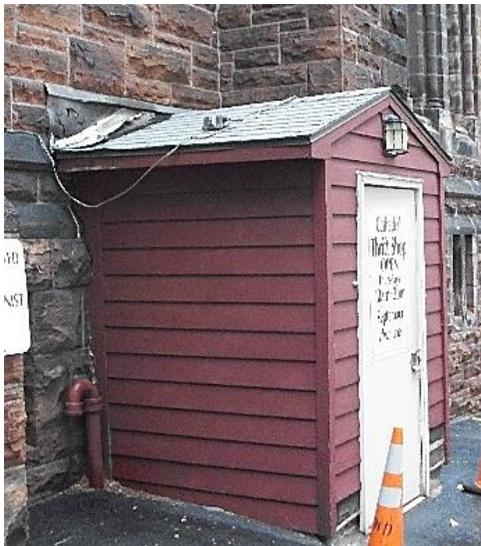
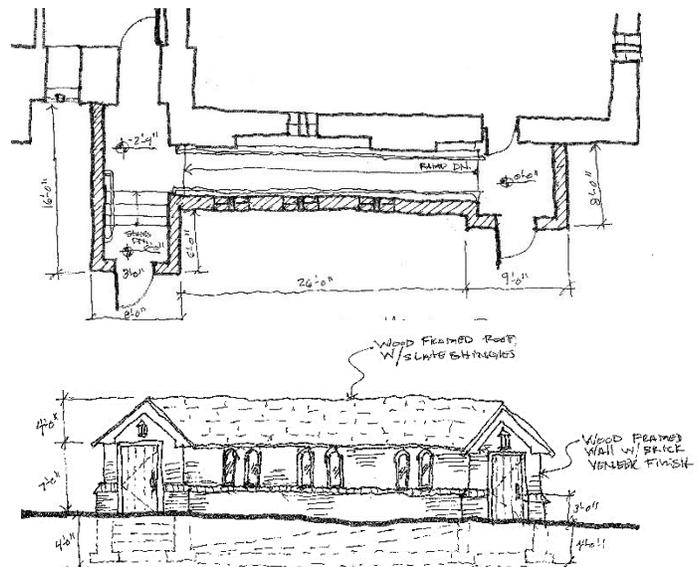
Replace the “Doghouse” entry with one in keeping with the dignity of the Cathedral that combines the Thrift Shop and Bishop’s entrances. The present “Doghouse” is: dilapidated and in jarring contrast to the Cathedral it serves; open to infiltration of water, cold air and small animals; and not handicap accessible. A new entrance combining the Thrift Shop and Bishop’s entrances would eliminate these conditions. Sketches by Lacey Thaler Reilley Wilson, Architects.

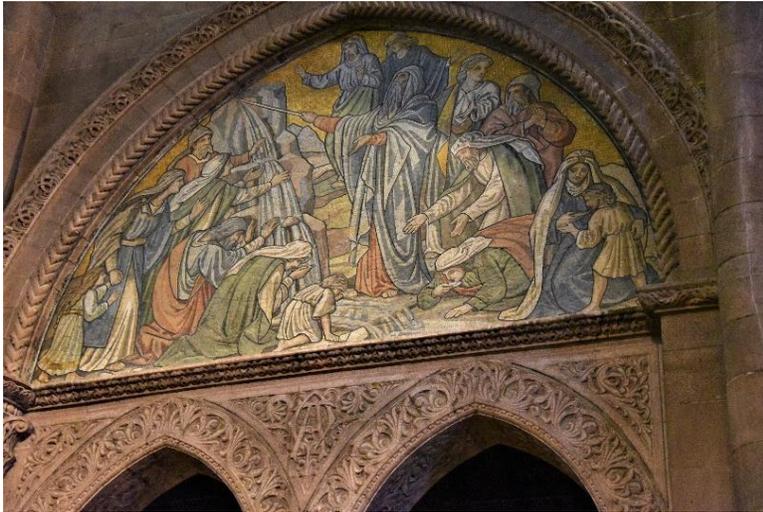
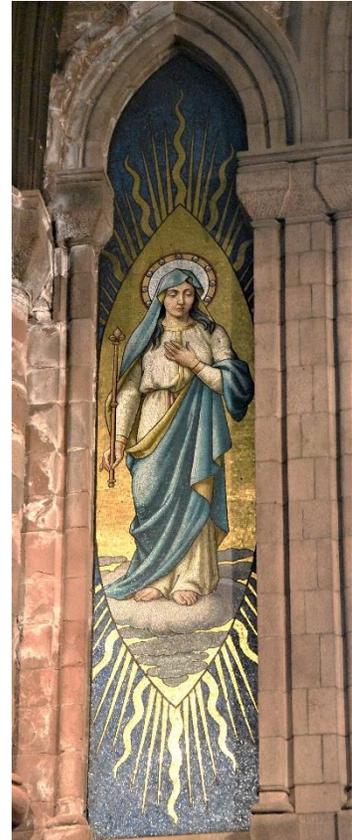
31. CHANCEL WALL MOSAICS (Source: Ad Hoc, restoration) Clean and repair these wonderful mosaic works of art on the north, east and south walls.

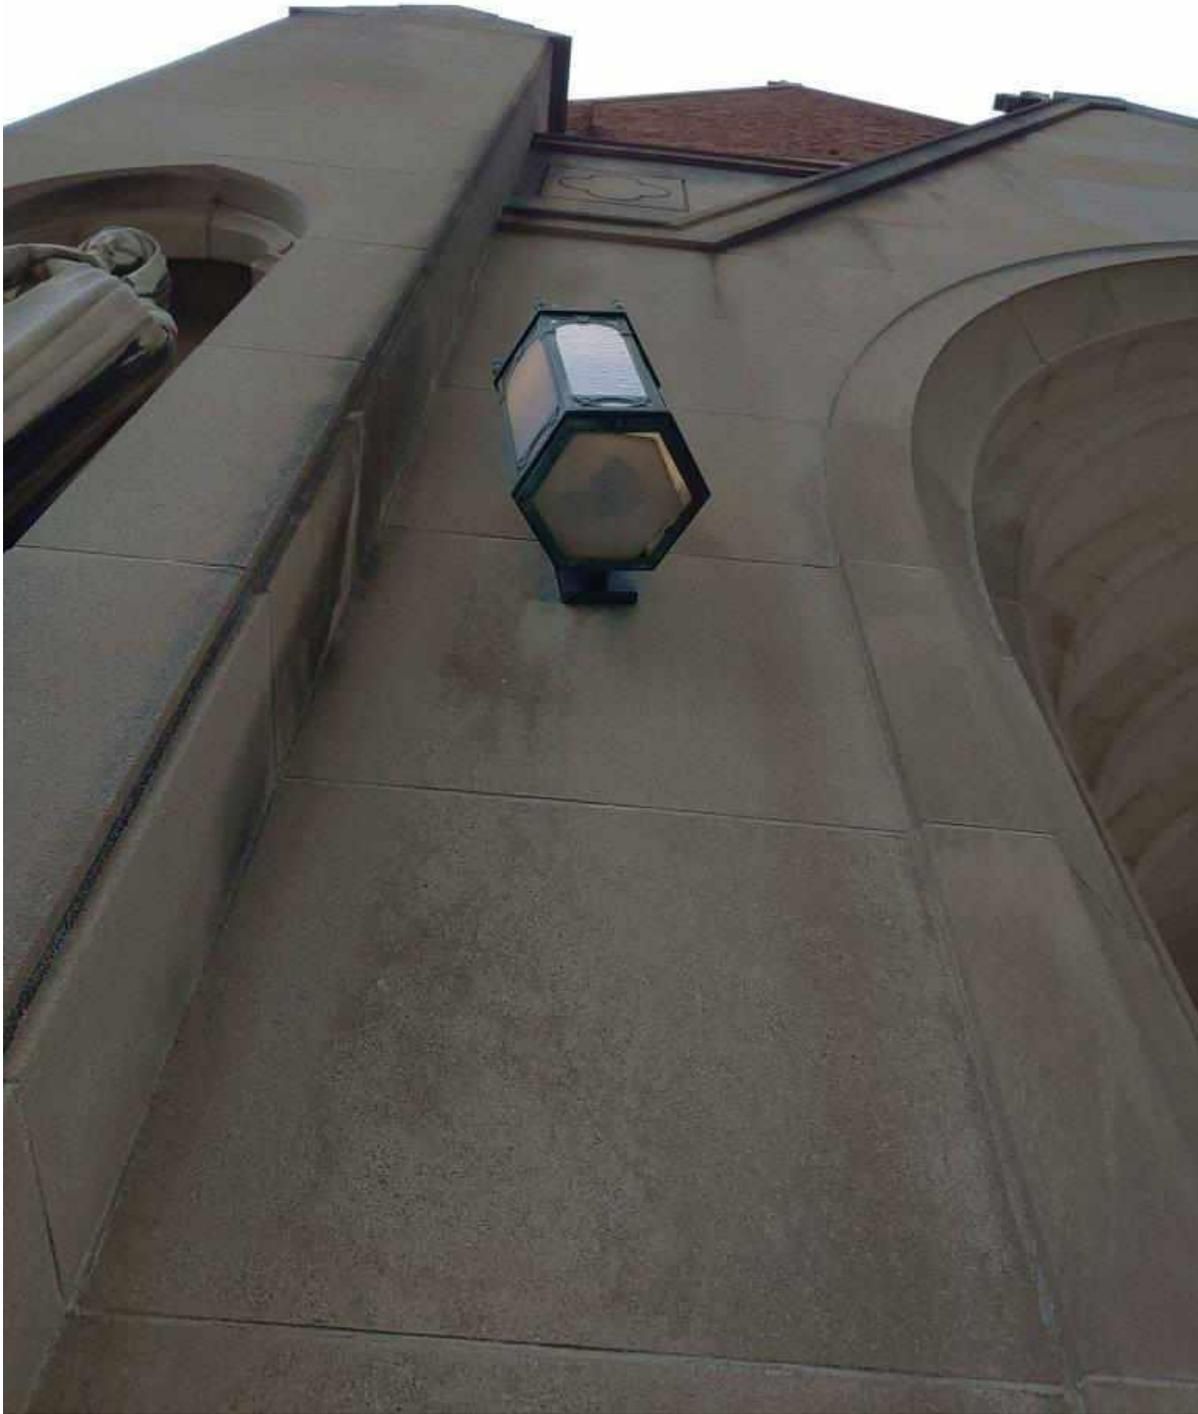
This light has been set plumb since this photo was exposed.
